## TEST CERTIFICATE

**CERTIFICATE NUMBER** 11368/01 – Issue 2

Description	Model Number	Serial Number
Infra-Red Patio Heater	HLW 15	Not Serialised
Also Representing:		
Infra-Red Patio Heater	HLW 10	Not Serialised
Infra-Red Patio Heater	HLW 20	Not Serialised

BS EN 60529, 1992, IP66 Category 1

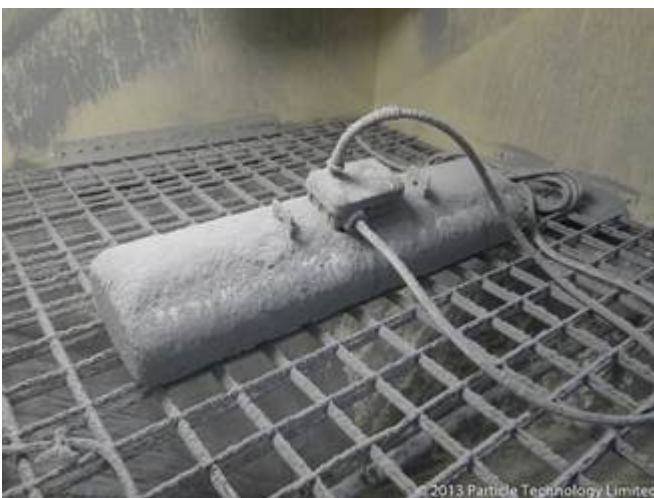
**Figure 1 – HLW 15 after IP6X dust test**

On completion of the test excess dust was removed by light brushing to allow inspection. No conspicuous damage was noticed on the exterior of the unit, there was no visible dust ingress into the electrical enclosure of the Patio Heater.

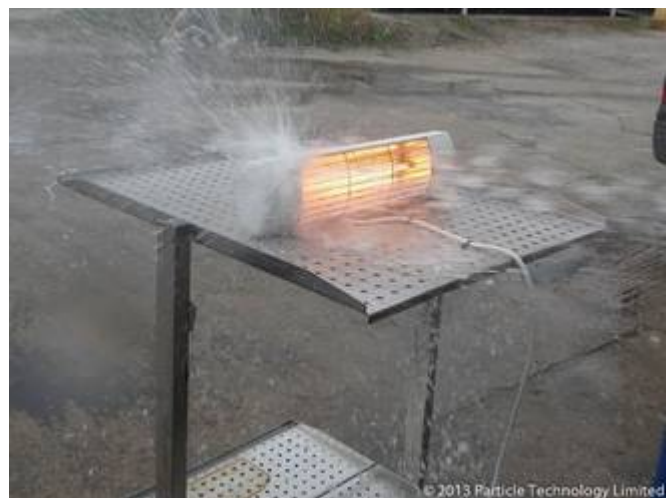
**Figure 2 - HLW 15 during IPX6 Water Test**

During testing the unit was powered and operational. The unit was then subjected to water from all directions for a period of 3 minutes; the test conditions were as follows:

On completion of the water test excess water was removed to allow inspection; there was no visible water ingress into the electrical enclosure of the Patio Heater.
